Storm Drain Pipe Rehabilitation on Cliffside Drive

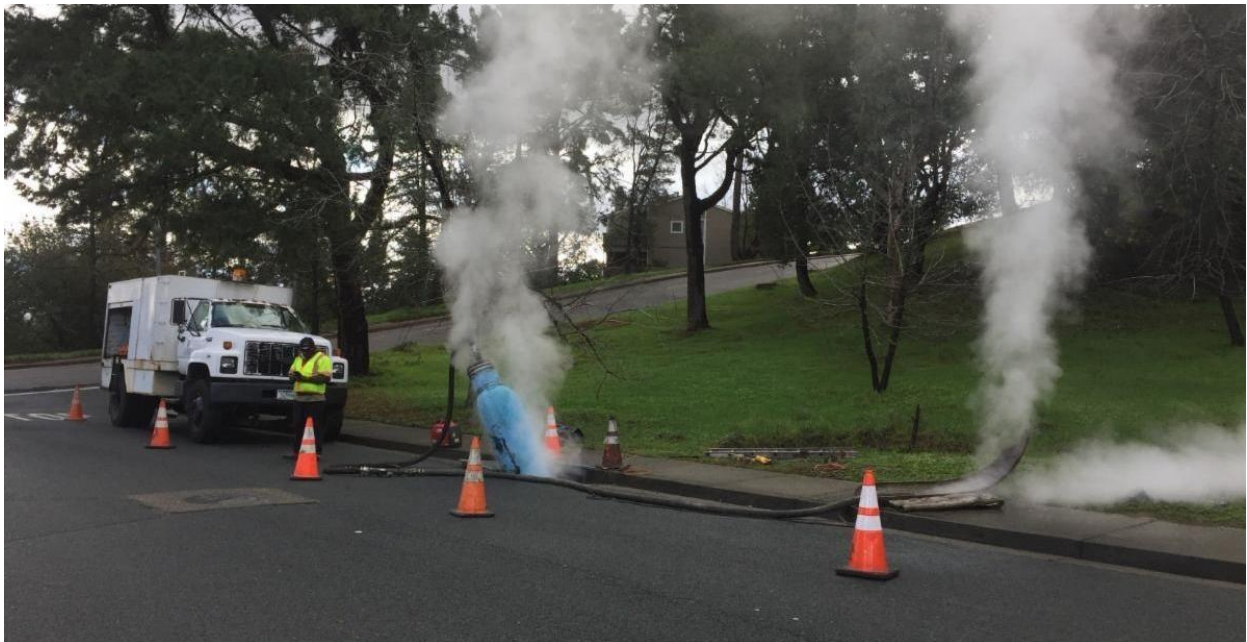
Earlier this year, staff hired Kerex Engineering to repair a 157-ft section of storm drain pipe on Cliffside Drive. The existing concrete pipe was displaced at the joints and leaking which caused a sinkhole at one location and the pavement along the pipeline to settle.

A Cured-In-Place-Pipe system (CIPP) was implemented, which is a trenchless rehabilitation method used to repair existing pipelines. It is a jointless and seamless pipelining within an existing pipe. The pipe begins as a flexible; resin-infused felt tube that is inserted within the existing pipe through the manholes (see photo). Once in place - steam is added and the curing process begins. The pipe liner (tube) molds itself to the shape of the existing pipe and hardens into a plastic pipe, creating a uniform lined pipeline system that will not leak. This method has been used in other areas of the City with success.

The pipe rehabilitation and pavement repairs on Cliffside Drive were completed the week of January 29th.
